## I N T E R N A L   M E M O R A N D U M

**To:** Phyllis Calloway, J.D.  
**From:** Yanni Spanoudakis, PE  
**Date:** March 17, 2025  
**Re:** Country Walk HOA Conservation Area Outfall Inspection

# COUNTRY WALK S/D STORMWATER MAP

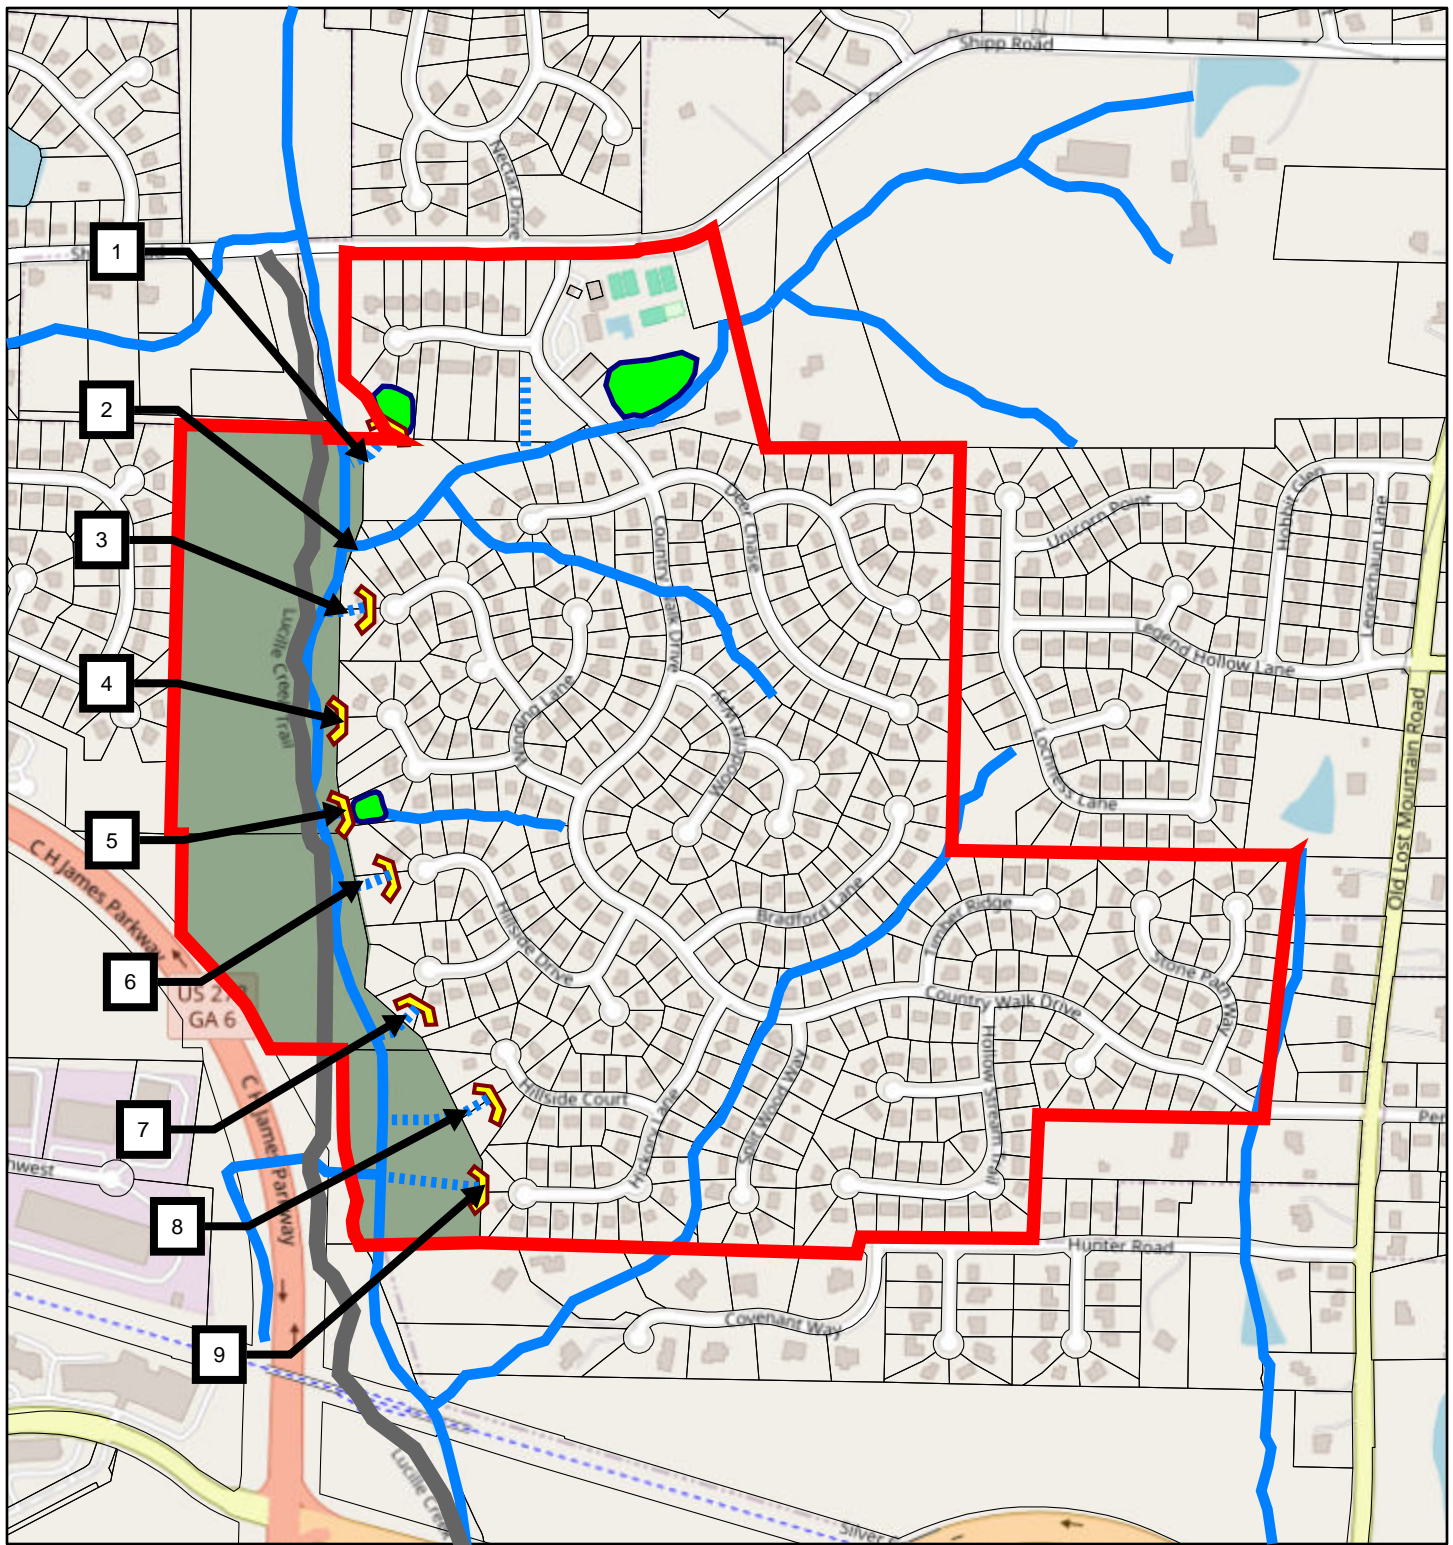
Lucille Creek – The banks and flow of the creek were inspected, and no blockages or noticeable eroded areas were observed.

1. Location of discharge from Country Walk stormwater pond, located at 4809 & 4811 Country Walk Estates Drive. Despite lack of rip rap stone observed at the downstream outlet pipe of the pond, minimal erosion appears to be occurring. There is a short defined downstream channel cut from the pond discharge that shortly dissipates into a mostly flat undefined area that

continues to flow west across the Cobb County Sewer Easement. I believe there to be no buffered state waters in this area. Eventually the stormwater enters Lucille Creek via two separate well-defined cuts in the creek banks. No current stormwater maintenance needs were observed to be present in this area. Lack of rip rap may allow for erosion downstream of the pond OCS during future heavy rain events.

2. Location of buffered state water flowing from east to west exiting the Country Walk S/D. The banks of the channel are heavily eroded close to the intersection with Lucille Creek. The erosion does not currently pose an immediate threat to any of the surrounding properties. The property with the highest risk is the sewer structures and pipes owned by Cobb County that cross the channel. Stream bank stabilization in this area would be encouraged to stop downstream sediment pollution but it is not necessary.

3. Location of discharge of pipe routing un-detained stormwater from stormwater structure in upstream cul-de-sac (Ramblewood Court). Discharge of pipe was observed to be 30% full of sediment. No rip rap was observed to be present. A large tree was observed to be located close to the pipe discharge and the tree appeared to be in good health. It was observed that downstream of the pipe discharge, a defined channel was present for approximately 10-ft at which point it dissipated into a mostly flat undefined area, though the route that the stormwater takes to reach Lucille Creek was apparent due to the displaced forest debris (leaves and pine straw). Eventually the stormwater enters Lucille Creek via a well-defined cut in the creek bank. No current stormwater maintenance needs were observed to be present in this area. Lack of rip rap may allow for erosion downstream of the pipe discharge during future heavy rain events. The large tree could be a potential future maintenance item.

4. Location of discharge of pipe routing un-detained stormwater from stormwater structure in upstream cul-de-sac (Saddlerun Lane). No clog apparent in pipe. No rip rap was observed to be present. Pipe discharges approximately 40-ft from Lucille Creek. A well-defined channel was observed from the pipe discharge to Lucille Creek. No current stormwater maintenance needs were observed to be present in this area. Lack of rip rap may allow for erosion downstream of the pipe discharge during future heavy rain events.

5. Location of discharge from Country Walk stormwater pond located at 4861 Saddlerun Lane. A well-defined channel was observed from the pipe discharge to Lucille Creek. Insufficient rip rap was observed to be present, along with the presence of moderate sediment erosion in the channel. The northern corner of the channel collapsed at the intersection with Lucille Creek, with an island of earth and 4 trees lying in Lucille Creek, the trees span westward over the creek and above the water level of the creek at the time of inspection. The 4 trees appear to have collapsed due to lack of erosion control in the channel used to carry the pond discharge to Lucille Creek. A second, separate single tree north of the conglomerate of the previously stated 4 trees also has fallen across the creek. This singular tree also spanned westward over the creek and above the water level of the creek at the time of inspection. The tree could have been pulled down when the previously mentioned group of 4 trees fell, but the reason for falling is unclear. The current stormwater maintenance needs in this area are unclear, (see list of uncertainties below). Insufficient rip rap may allow for erosion downstream of the pond OCS during future heavy rain events. The trees over the creek may cause a blockage on Lucille Creek in the future.

6. Location of discharge of pipe routing un-detained stormwater from stormwater structure in upstream cul-de-sac (Hillside Drive). Discharge of pipe was observed to be 25% full of sediment. No rip rap was observed to be present. It was observed that, downstream of pipe discharge, a defined channel was present for approximately 10-ft at which point it dissipated into a mostly flat undefined area. It is unclear where the stormwater enters Lucille Creek, as no well-defined cut in the creek bank was observed. No current stormwater maintenance needs were observed to be present in this area. Lack of rip rap may allow for erosion downstream of the pipe discharge during future heavy rain events.

7. Location of discharge of pipe routing un-detained stormwater from stormwater structure in upstream cul-de-sac (Buckhorn Court). Discharge of pipe was observed to be 75% full of sediment. No rip rap was observed to be present. No defined channel was present. Discharge from pipe dissipated into a mostly flat undefined area. It is unclear where the stormwater enters Lucille Creek, as no well-defined cut in the creek bank was observed. Clean out of sediment from discharge pipe is the only stormwater maintenance need observed to be present in this

area. Lack of rip rap may allow for erosion downstream of the pipe discharge during future heavy rain events.

8. Location of discharge of pipe routing un-detained stormwater from stormwater structure in upstream road (Hillside Court). No rip rap was observed to be present. No defined channel was present. Discharge from pipe dissipated into a mostly flat undefined area. It is unclear where the stormwater enters Lucille Creek, as no well-defined cut in the creek bank was observed. No current stormwater maintenance needs were observed to be present in this area. Lack of rip rap may allow for erosion downstream of the pipe discharge during future heavy rain events.

9. Location of discharge of pipe routing un-detained stormwater from stormwater structure in upstream cul-de-sac (Hickory Lane). Discharge of pipe was observed to be 50% full of sediment. No rip rap was observed to be present. No defined channel was present. Discharge from pipe dissipated into a mostly flat undefined area. It is unclear where the stormwater enters Lucille Creek, as no well-defined cut in the creek bank was observed. Clean out of sediment from discharge pipe is the only stormwater maintenance need observed to be present in this area. Lack of rip rap may allow for erosion downstream of the pipe discharge during future heavy rain events.
