RE: Brownsville Road Site Concept Plan

At your request and I walked the property at the corner of Brownsville Road and Oglesby Road in Powder Springs yesterday afternoon to review and assess trees in south east corner where wetlands and stormwater detention are proposed as well as around the perimeter of the site in relation to the schematic plan.

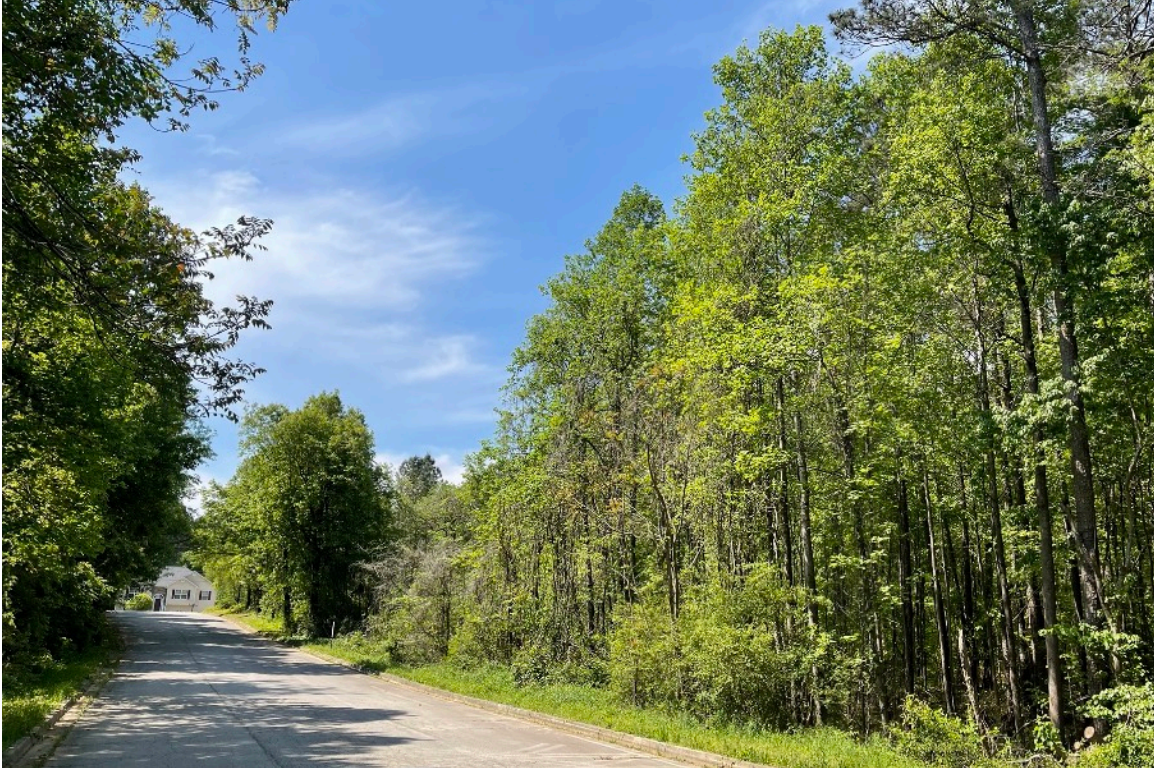
The current schematic plan shows the stormwater detention improvements would be in an area primarily dominated by small diameter sweetgum, red maples, tulip poplars, and some loblolly pines (Figures 1 and 2). These trees are of low value especially when compared with new hardwood plantings adapted to the conditions of the site. Selections should include:

Figure 1 - Area of proposed stormwater detention includes small diameter, low value trees. Viewing from north to south.

- Overcup oak (*Quercus lyrata*)
- Nuttall oak (*Quercus nuttallii*)
- Willow oak (*Quercus phellos*)
- Bald cypress (*Taxodium distichum*)
- American elm (*Ulmus americana*)

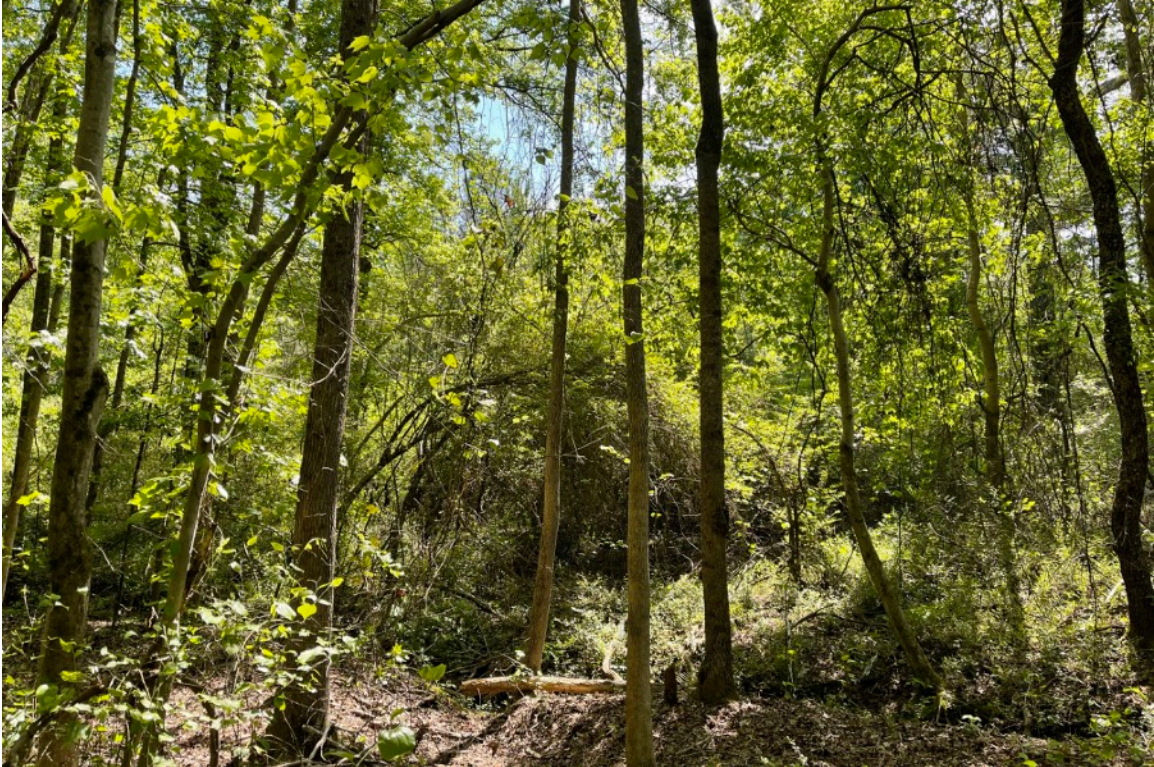
Figure 2 - Area of proposed stormwater detention includes small diameter, low value trees. View from interior of wetland looking towards drive at east side of property.

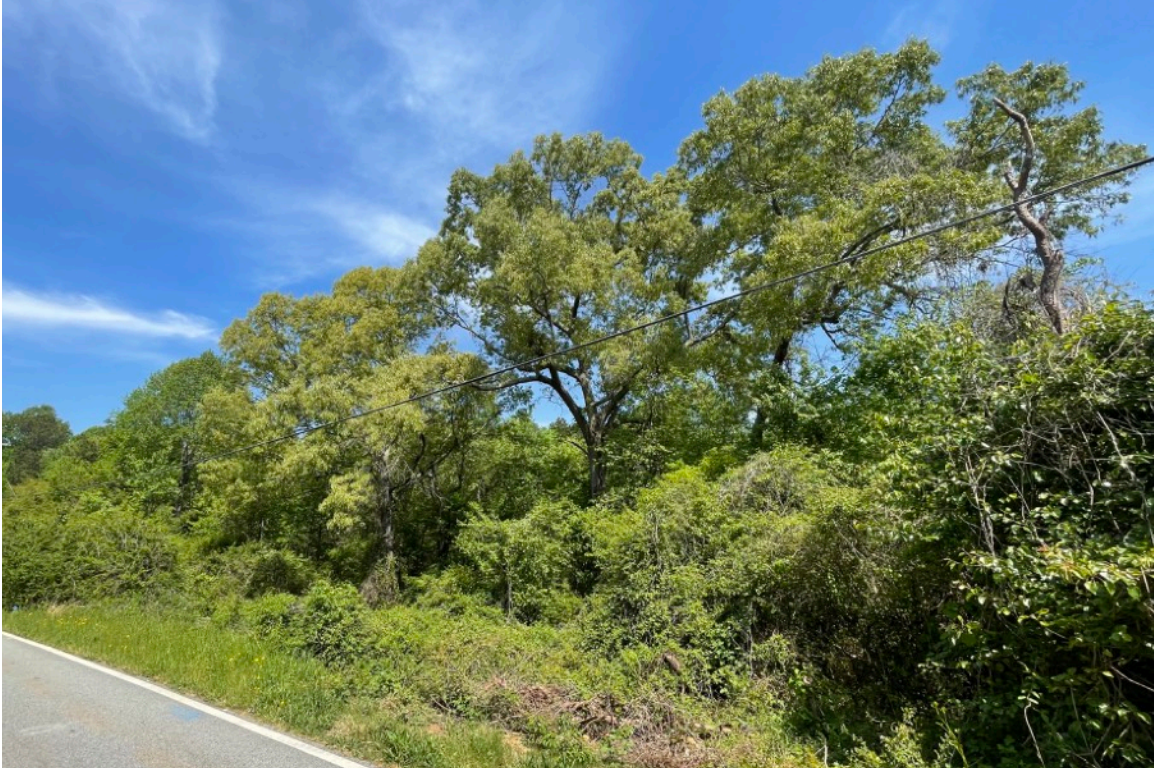
Detention placement also appears to spare the majority of the large diameter trees on the site. This includes oaks, red maples and tulip poplars along Oglesby Road south of the wetland (Figure 3). Invasive species are present in the immediate frontage along Oglesby with multiflora rose, callery (Bradford) pear, Chinese privet, and bamboo (Figures 4 and 5) all present. Conceptual plans including a nature trail and well-suited native plantings in this area would improve long-term viability of the green space and better green infrastructure.

Figure 3 - Large southern red oaks along Oglesby Road.

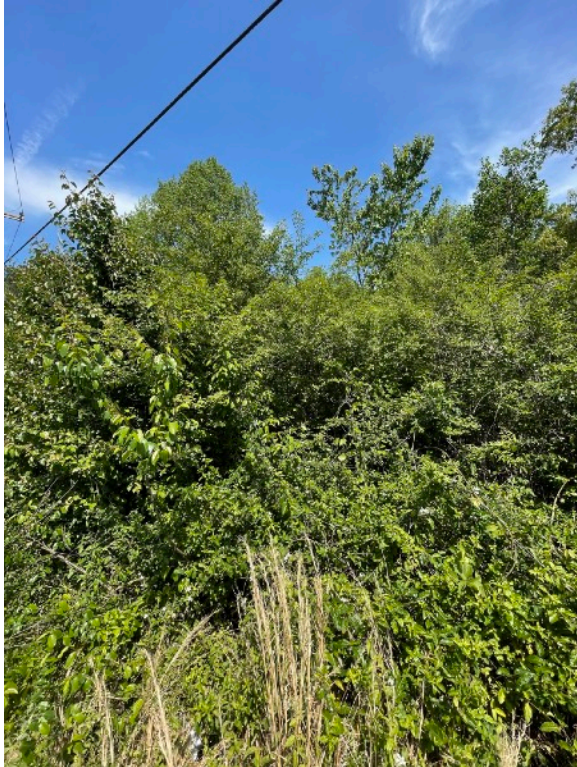
Figure 4 - Invasive species along Oglesby Road frontage.

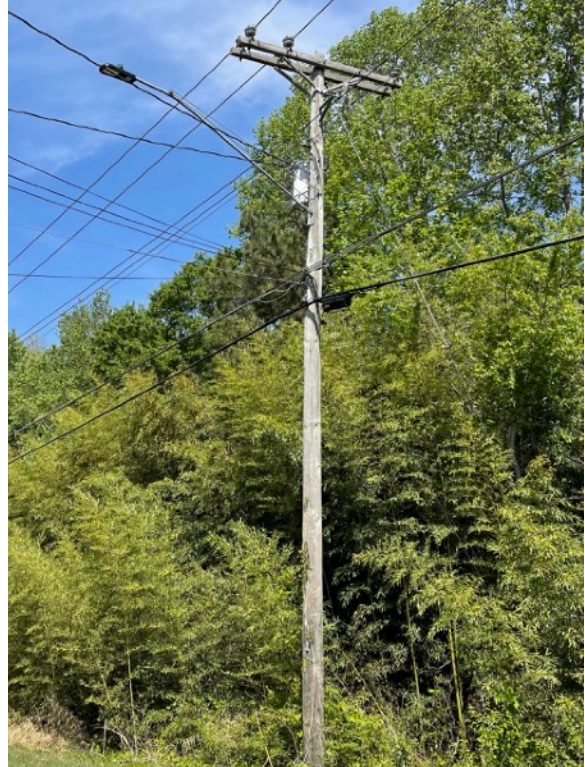
Figure 5 - Invasive species along Oglesby Road frontage.
